# HM Submarine A7

## An Archaeological Assessment

A report on the results of the A7 Project 2014

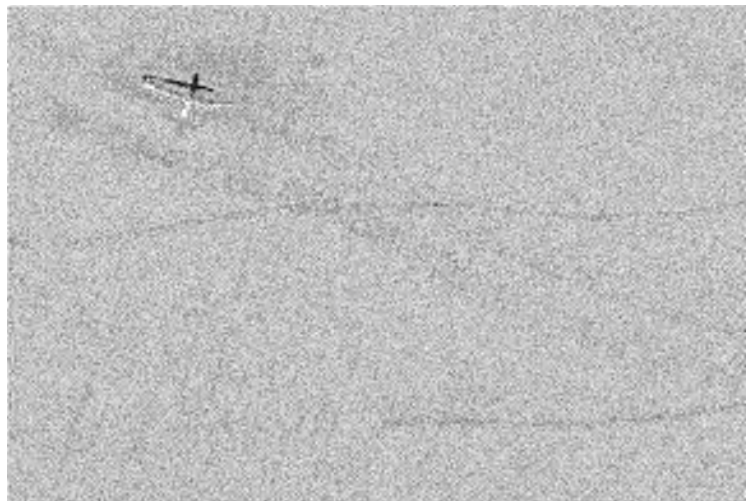
Scars on the seabed were noted on the sonar record which are thought to be made by fishing trawls. The original sandy seabed around the submarine has been covered in a thick layer of fine silt deposited during recent dumping operations on the disposal site to the east so the seabed seen today is recent. The trawl scars suggest that fishermen are trawling within 20m of the hull and as they can still be seen this activity is likely to have happened recently (Fig. 21).

*Figure 21: The two dark lines south and east of A7 are scars on the seabed made recently by trawl fishing*

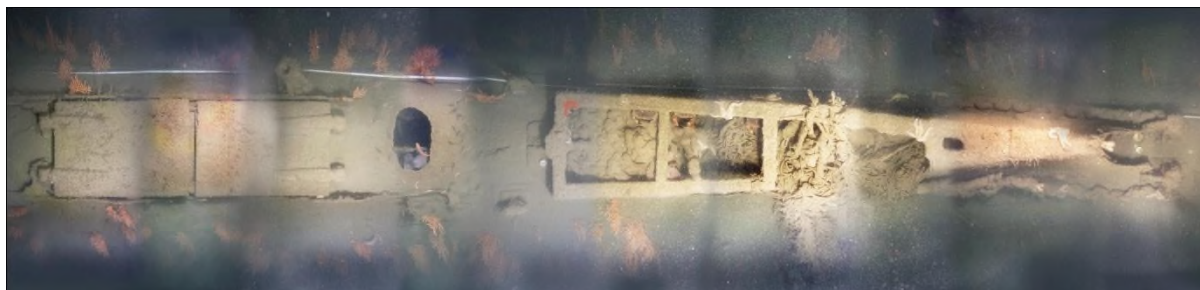
*Figure 30: Photomosaic of the bow of A7 showing the torpedo loading hatches, hole H3 and the remains of the cutwater*

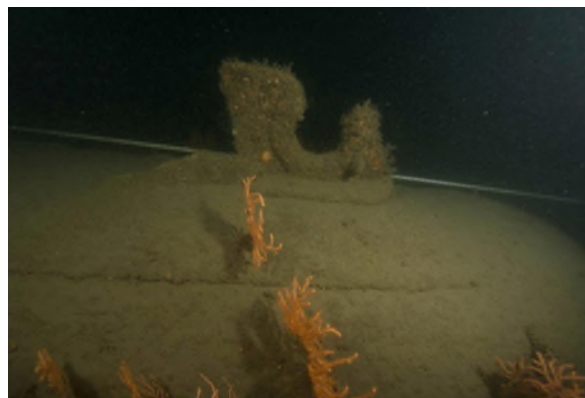
Figure 38: The remains of the towing eye from the starboard side, showing the missing upper quarter

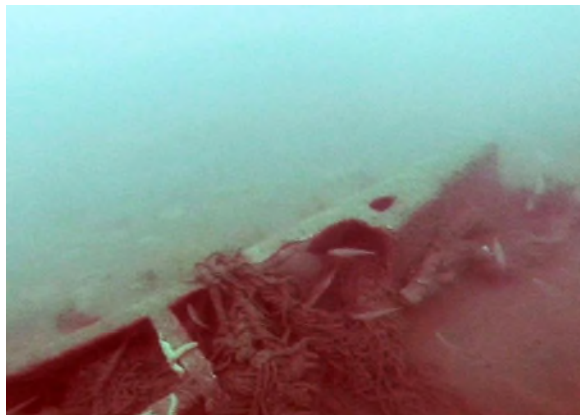
*Figure 40: The remains of the chain locker in the cutwater from the starboard side*

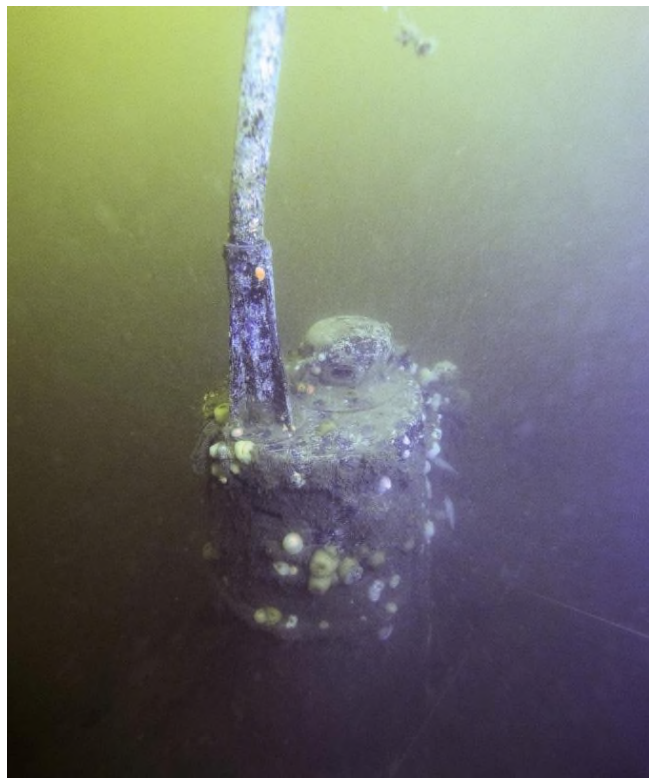
*Figure 51: Conning tower top and periscope from the port side looking aft. The bend in the periscope can be seen just above the supporting collar*

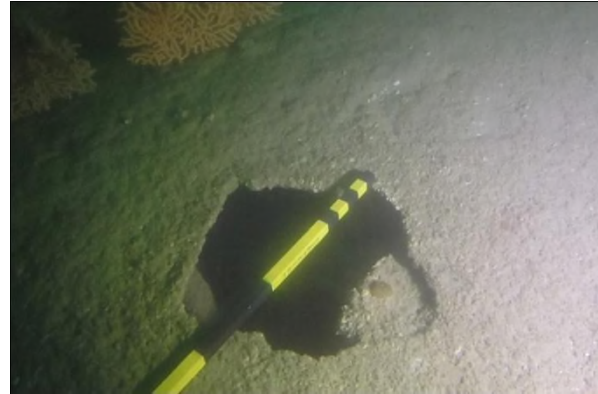
*Figure 56: Hole H1 on the starboard side*

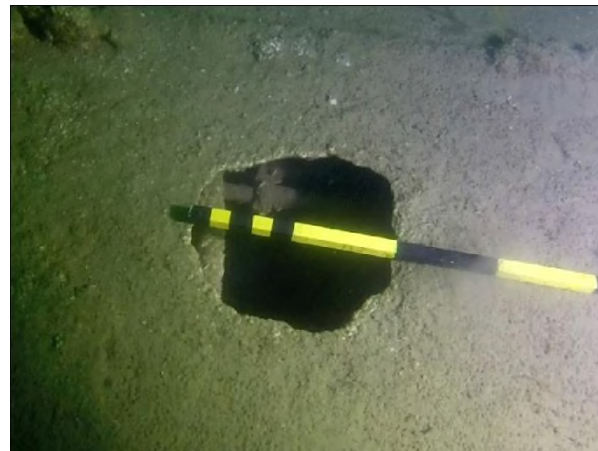
*Figure 57: Hole H2 in the stern*

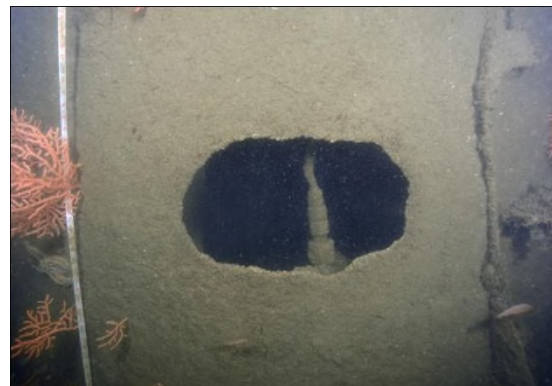
*Figure 58: Hole H3 in the bow*

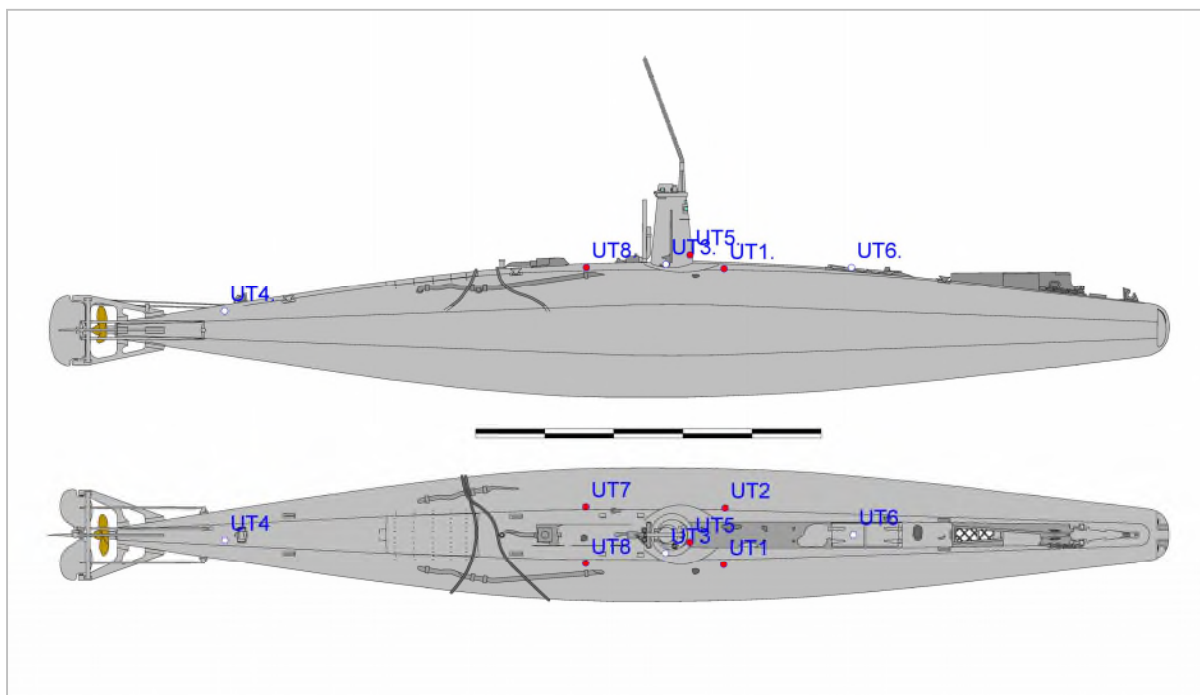
*Figure 63: Ultrasonic thickness measurement points on the hull of the A7*

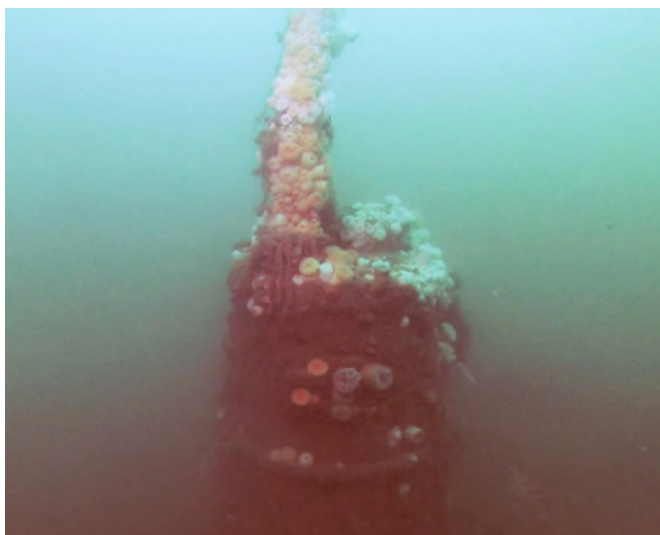
Figure 64: The conning tower and periscope before cleaning, showing the full complement of anemones
