# HM Submarine A7

## An Archaeological Assessment

A report on the results of the A7 Project 2014

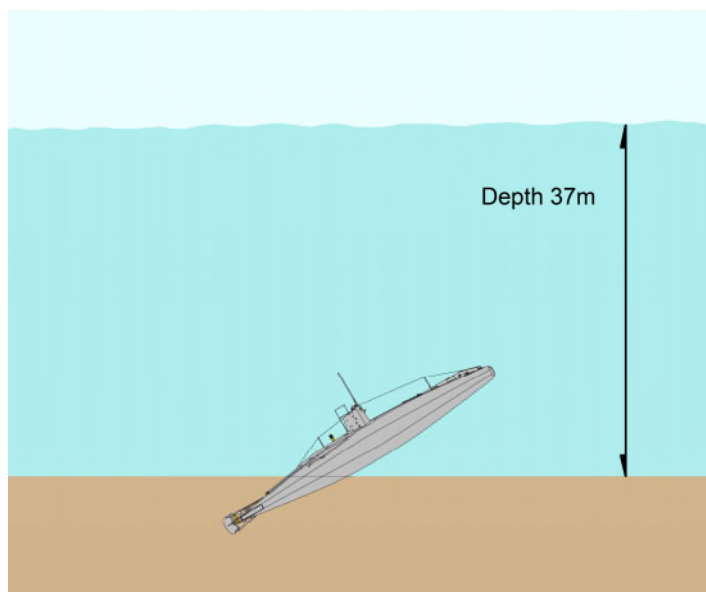
| Subject | Report on the archaeological assessment of HM Submarine A7 in 2014 |

The wreck was found in 37m depth with between six and seven metres of the submarine's stern buried in the muddy seabed and the bow 10m off the bottom<sup>23</sup>, raised at an angle of 30° to 40° (Fig. 12). Most of the submarine was below the maximum operating depth of 30m and the deepest part of the hull was at a depth of 40m.

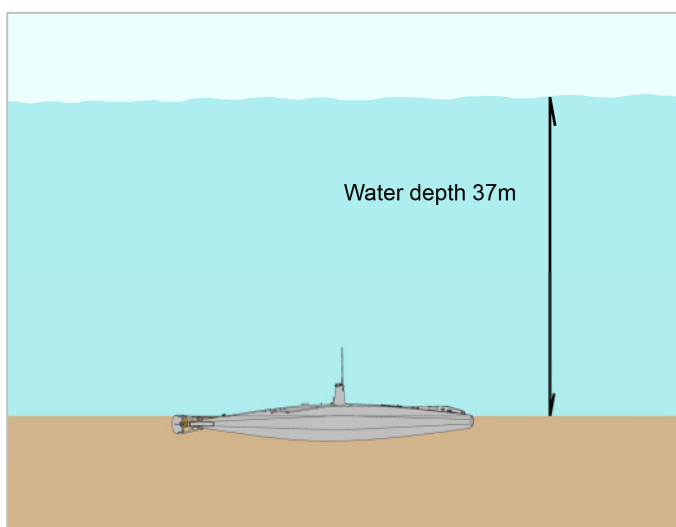
*Figure 17: A7 as she lies today in 37m water depth, partially buried in the seabed*

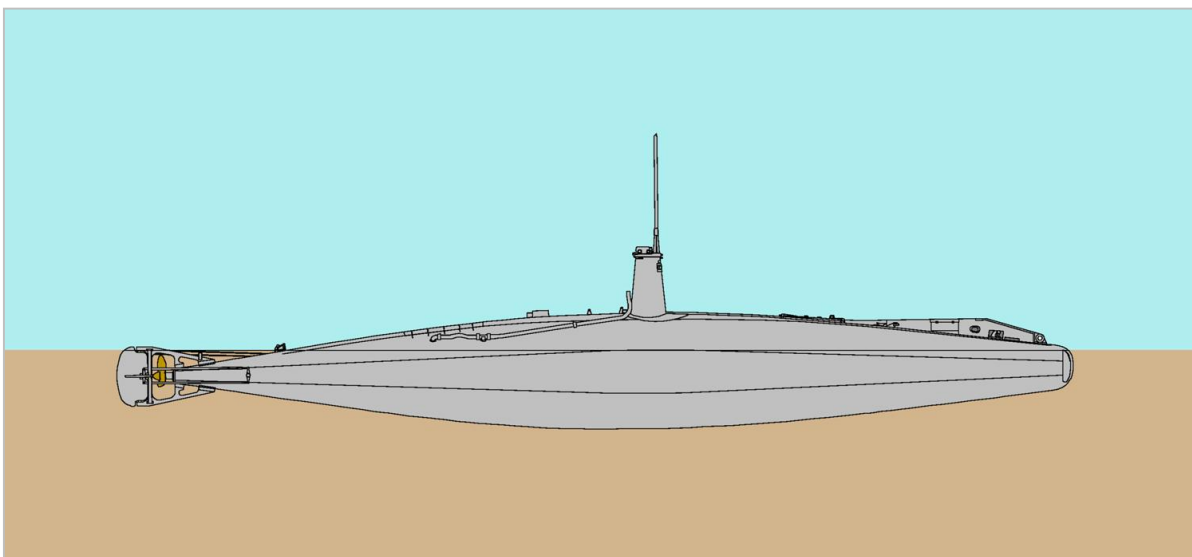
When the wreck of the submarine was first found in 1914, between six and seven metres of the submarine's stern was buried in the seabed and the bow was 10m off the bottom, raised at an angle of 30° to 40°. All contemporary salvage attempts failed and the submarine was abandoned on the seabed. Sports divers first visited the site in 1981 and found that the submarine was now on an even keel, she was largely intact but buried right up to what would be her waterline when afloat and in light ballast. The last sports divers to legally visit the site in August 2002 reported that the submarine was essentially in the same condition as it was found in 1981 (Fig. 19).

*Figure 19: Estimate of hull attitude and burial depth based on divers' reports*

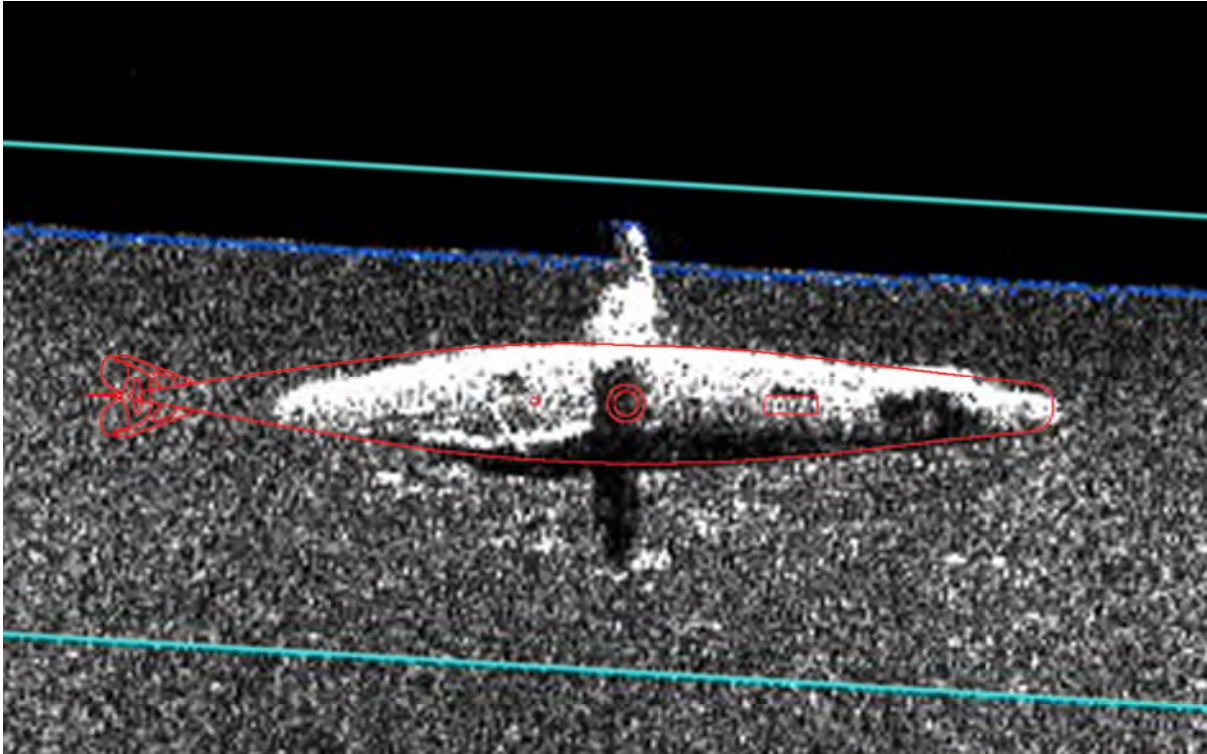
*Figure 20: 2013 side scan sonar image overlaid with the outline of the hull*

The bow of the submarine points to the north west and the aft four metres of the submarine hull, propeller, hydroplanes and rudder appeared to be buried (Fig. 20). The sonar image showed a 1.4m long dark feature on the hull 4m forward of the conning tower which corresponds with the torpedo loading hatch (red rectangle). This initially suggested that the hatch was open so the MOD was alerted to the possibility. It was subsequently found that the hatch was shut and this was simply a sonar artefact caused by the hatch itself.

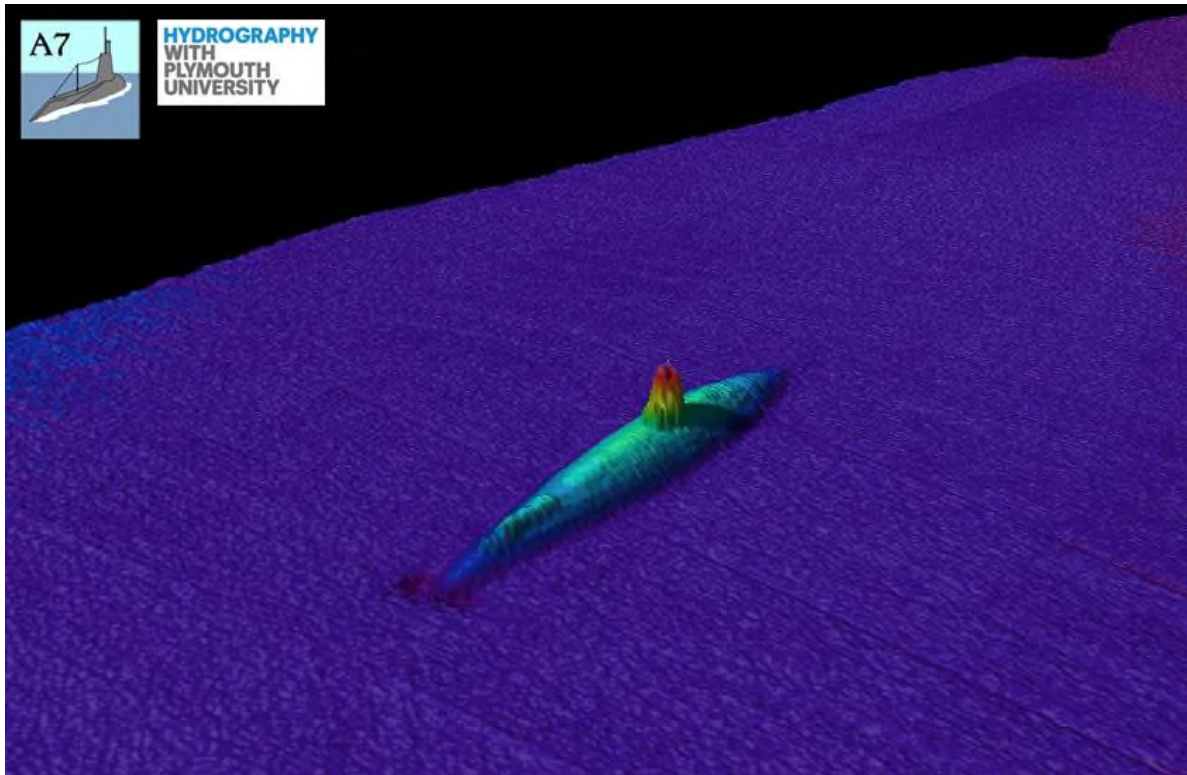
Figure 24: Three-dimensional model of the A7 submarine created from the multibeam sonar data, showing the submarine partially buried in the flat seabed and the small scour round the bow.

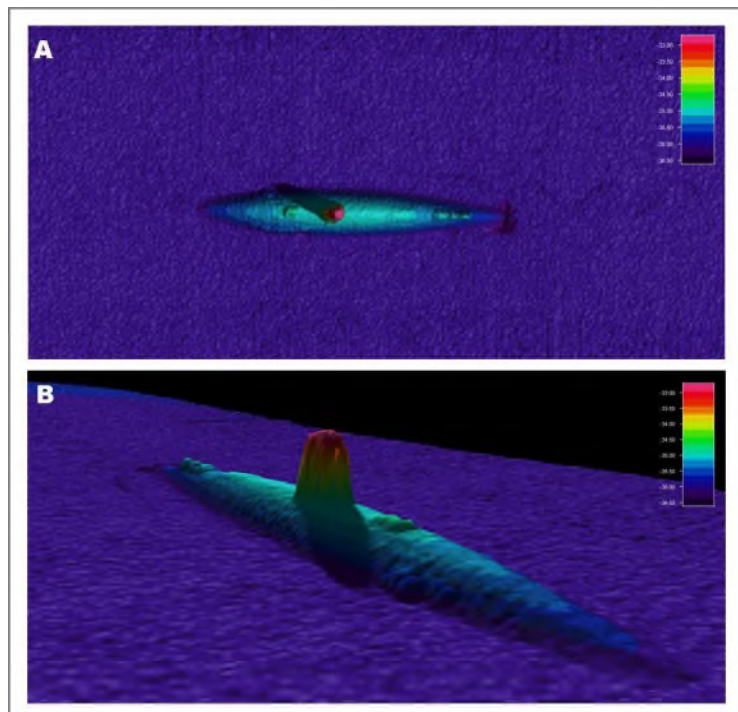
The results of the high resolution (700kHz) multibeam echo sounder (MBES) survey were used to create a detailed three-dimensional model of the wreck and seabed around it (Fig. 25, 25). The sonar showed the submarine to be as estimated from the previous side scan survey: largely intact, upright, with bows to the north-west and buried up to her waterline. The conning tower is shown along with the remains of the cutwater on the bow and the binnacle mounting aft.

Of the 30.2m length of A7 just 25.4m is visible on the surface. The deck is 1.1m proud of the seabed at the highest point near the conning tower and the tower itself extends a further 2.2m above the seabed. At the widest point on the hull the visible part of the submarine is 3.97m wide.

Figure 25: Two views of the 3D model from above and from the port side stern looking forward

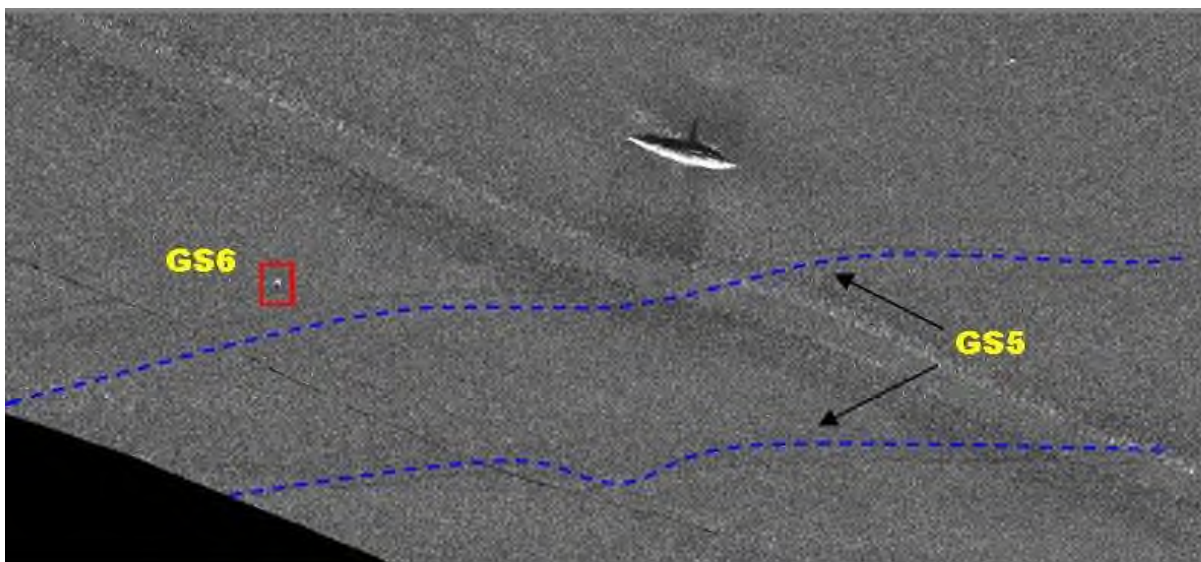
Only one target (GS6) was detected near the submarine at 50° 18.510 N 004° 18.075 W; the object was 1.8m long and proud of the seabed. This target was not considered significant as it was 85m from the hull so was unlikely to be associated with it (Fig. 27). The recently deposited soft sediment covering the seabed in the area is likely to have buried any small objects from the submarine that were lying close to it, so they would not be detected with the side scan sonar.

Figure 27: Mosaic of the GeoAcoustics side-scan sonar survey at 410kHz (Doble 2014)

The feature GS5 in Fig. 27 are scars on the seabed made by a fishing trawl net.

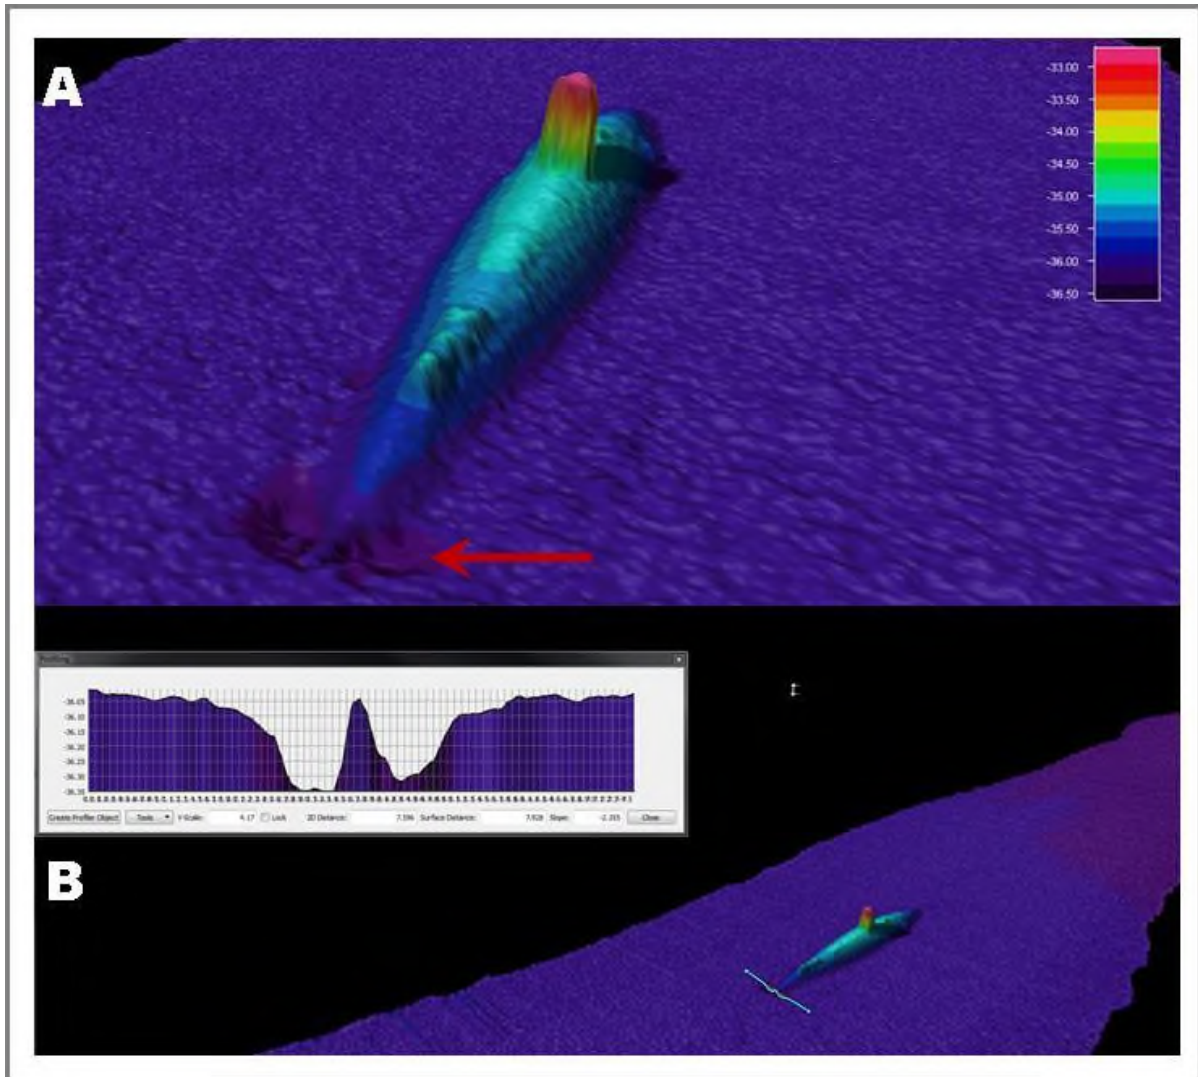
The 3D model of the submarine and seabed recorded by the multibeam sonar clearly shows a scour pit formed around the bow, the pit is 0.3m in depth and approximately 3m wide (Fig. 28). The scour has been formed by tidal currents flowing around the submarine and is a common feature of shipwrecks buried in soft sediments. The scour around the bow allows more of the torpedo tube shutters to be seen than would otherwise occur.

Figure 28: Bow view of the 3D sonar model (A) and a cross section through the bow scour (B)

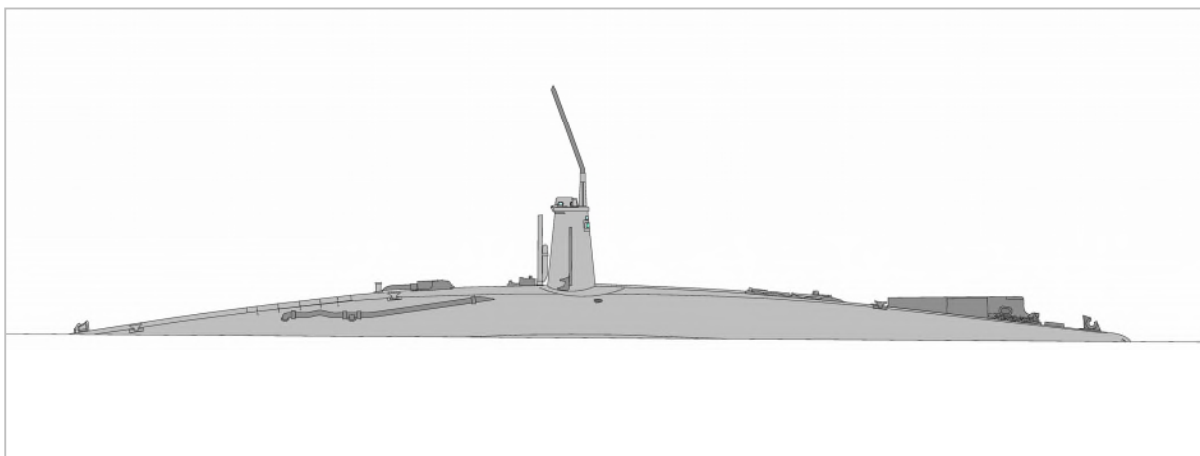
The three-dimensional model of the submarine created by the multibeam sonar data was used as the starting point for the detailed recording. From the sonar survey we knew that A7 was largely intact, upright, with bows to the west, the periscope was bent backwards and the hull was partially buried in the seabed, as shown in Fig. 29.

*Figure 29: Starboard side elevation of the visible part of the submarine as seen in 2014, created using the Project survey results*

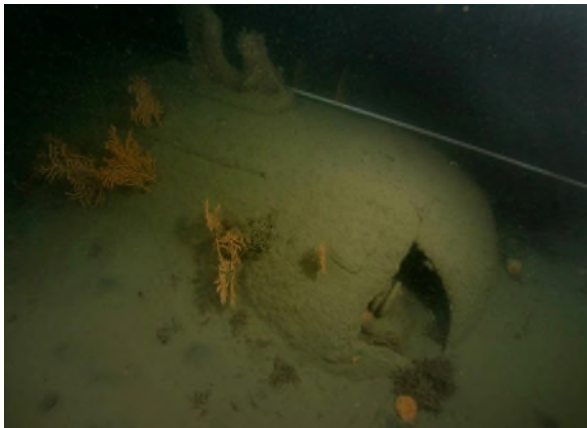
*Figure 34: Starboard bow looking aft, showing remains of the torpedo tube shutter and worm drive for opening the tube bow cap*

On the A7 submarine both torpedo tube caps are closed and the shutters are down but both access panels and chains are missing. Photographs of A class submarines in service show them fitted both with and without these panels so they may not have been fitted to the boat when A7 sank. At the current burial depth of the hull the torpedo tube caps and opening mechanism should not be as exposed; however the shallow scour pit formed around the bow of the submarine allows more of the bow features to be seen (Fig. 34).

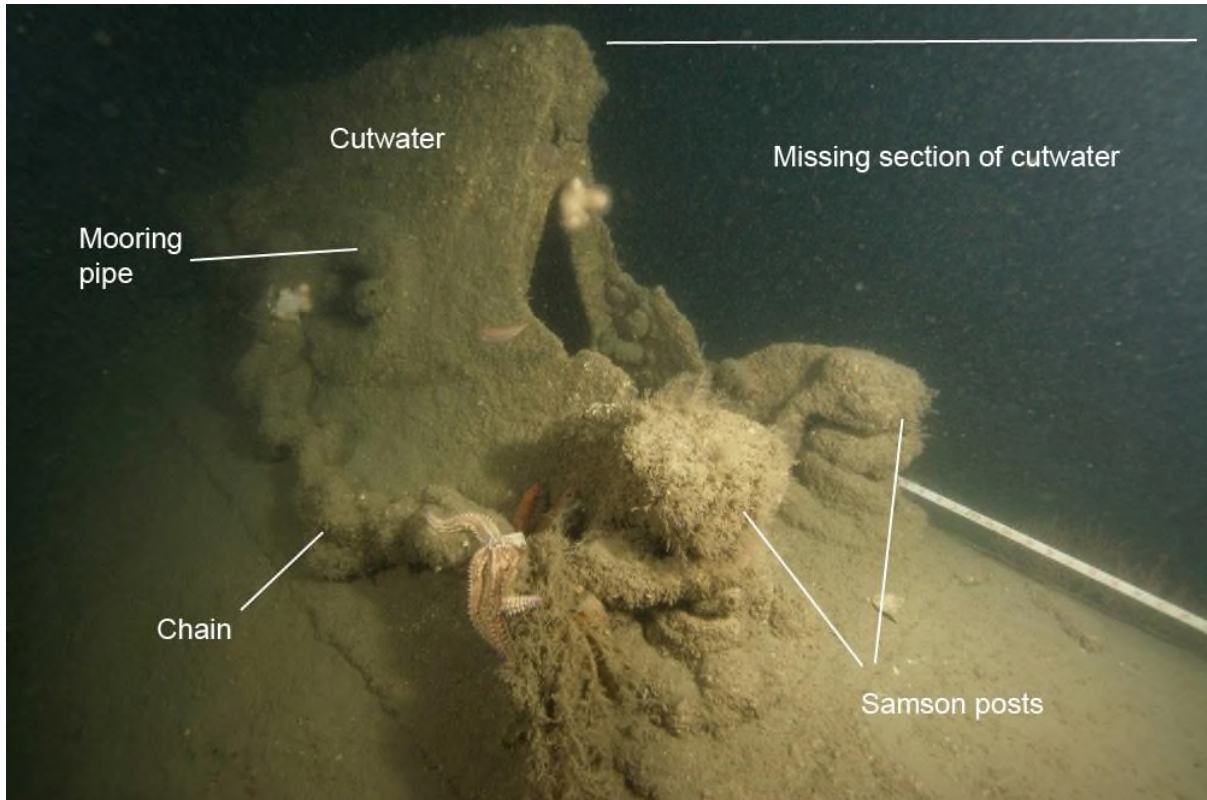
The forward part of the cutwater is also completely missing, from the aft end of the towing eye to just aft of the two Samson posts mounted on the pressure hull forward of the mooring pipes. The remainder of the cutwater frame is still in place and in good condition. The missing forward section of the Cutwater may have been damaged during salvage work as parts of the structure were reported to have been recovered back to the surface<sup>84</sup>.

The two Samson posts are still securely attached to the hull (Fig. 39). The remains of a towing pennant is attached to each of the Samson posts with a short length of chain that were used to reduce the effects of chafing on the cable when towing. The eye of the pennant wire is in place but the wire itself has corroded away on both sides, but on the port side the eye at the other end of the towing pennant can still be seen aft of the conning tower.

*Figure 39: Cutwater and fittings on A7 from the starboard side looking aft*

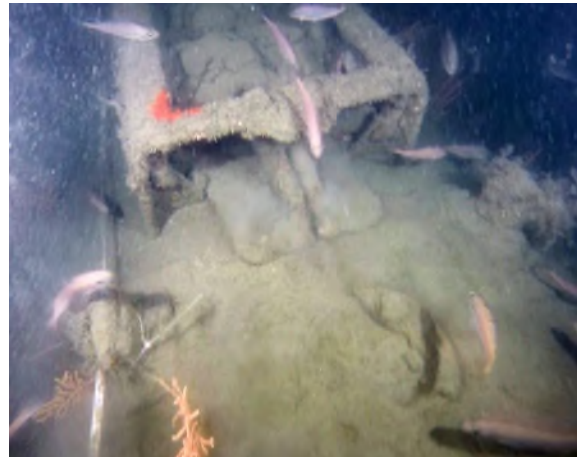
The small anchor and chain can still be seen in the aft section of the cutwater, with the remains of the anchor strong point underneath still firmly fixed to the hull (Fig. 41).

The bracket that mounted the forward stanchion has been broken so only a small part of the circular base plate remains.

*Figure 41: Aft end of the cutwater looking forward, showing the two bitts, the remains of the stanchion bracket and the anchor strong point*

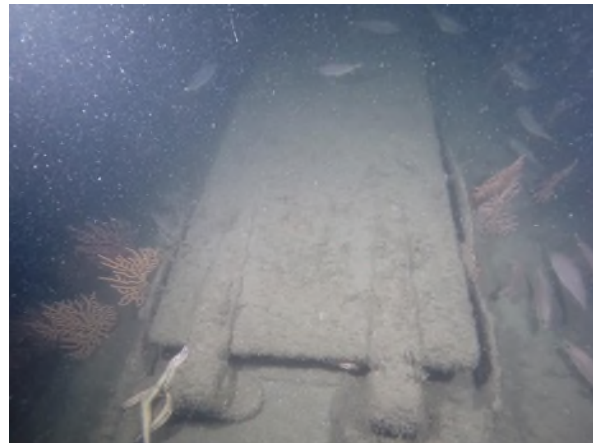
The two rectangular torpedo loading hatch doors are firmly closed (Fig. 42). It is not clear if the hatches cover two separate rectangular holes in the hull or the two cover one larger hole. One larger hole would be more useful but there would be difficulty sealing it against the water pressure in the middle where the hatches meet. Contemporary photographs suggest that there are two separate rectangular holes.

*Figure 42: The aft torpedo loading hatch*

The port side of the aft door appears to have been levered up slightly, damage thought to have been done by visiting divers attempting to gain entry to the submarine<sup>85</sup>.

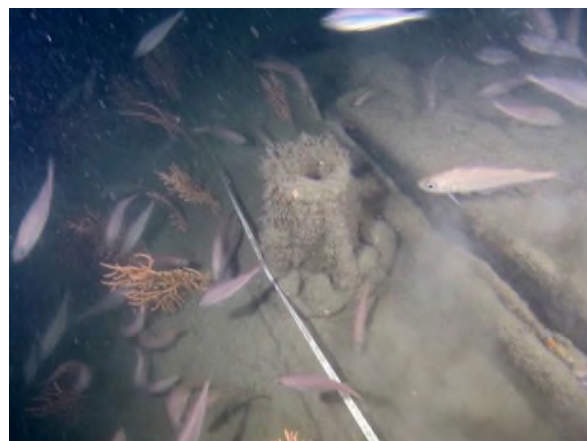
At the forward end of the hatch on the port side is the vertical circular webbed bracket for mounting the removable davit that could be fitted to assist loading torpedoes through the hatch (Fig. 43).

*Figure 43: Torpedo loading davit bracket*

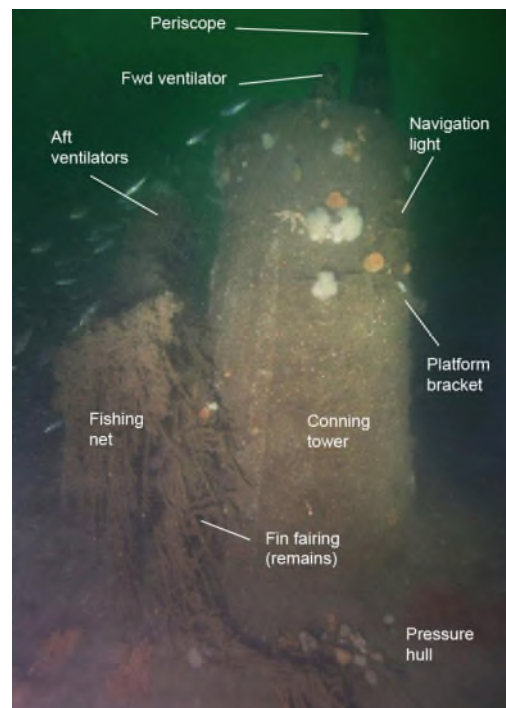
The conning tower is still intact: this forms part of the pressure hull. The free flooding fairing was made of thin steel plate and has either been removed during contemporary salvage attempts or has simply eroded away.

The entire fairing is missing apart from one small fragment each attached to the conning tower at deck level on both sides, as well as a thin strip down each side of the conning tower where the forward end of the fairing was attached (Fig. 45).

Figure 45: The conning tower from the starboard side

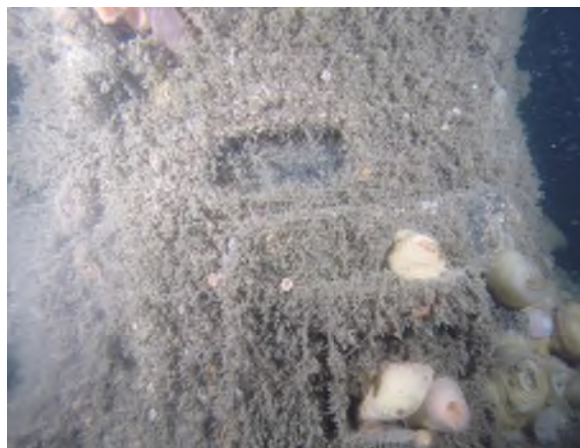
There are two small rectangular scuttles (windows) mounted on the front of the conning tower just above the navigation lights. The scuttles would allow some light in to the conning tower and would allow a limited view forward. The glass in both scuttles is still intact (Fig. 46).

*Figure 46: Intact scuttle on the port side*

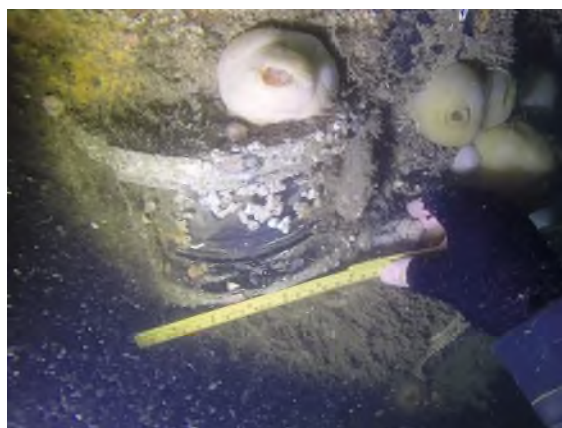
Two navigation lights were mounted on the front of the conning tower above the platform, one on the port side and one on the starboard, with blinkers on the inboard side to restrict the angle over which each light could be seen. It had been reported that by August 2001 the navigation lights had been removed from the conning tower<sup>86</sup> but the port light is still in place and just the starboard one has been removed. The port light is in good condition with the glass lens intact (Fig. 47).

*Figure 47: Intact navigation light on the port side*

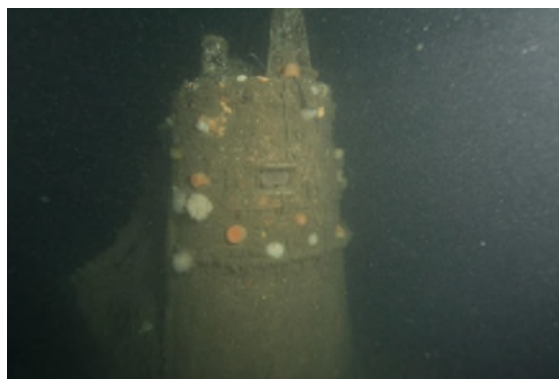
*Figure 48: Conning tower looking aft; the remains of the horizontal platform bracket can be seen half way down*

The remains of the bracket that attached the platform to the conning tower can still be seen.

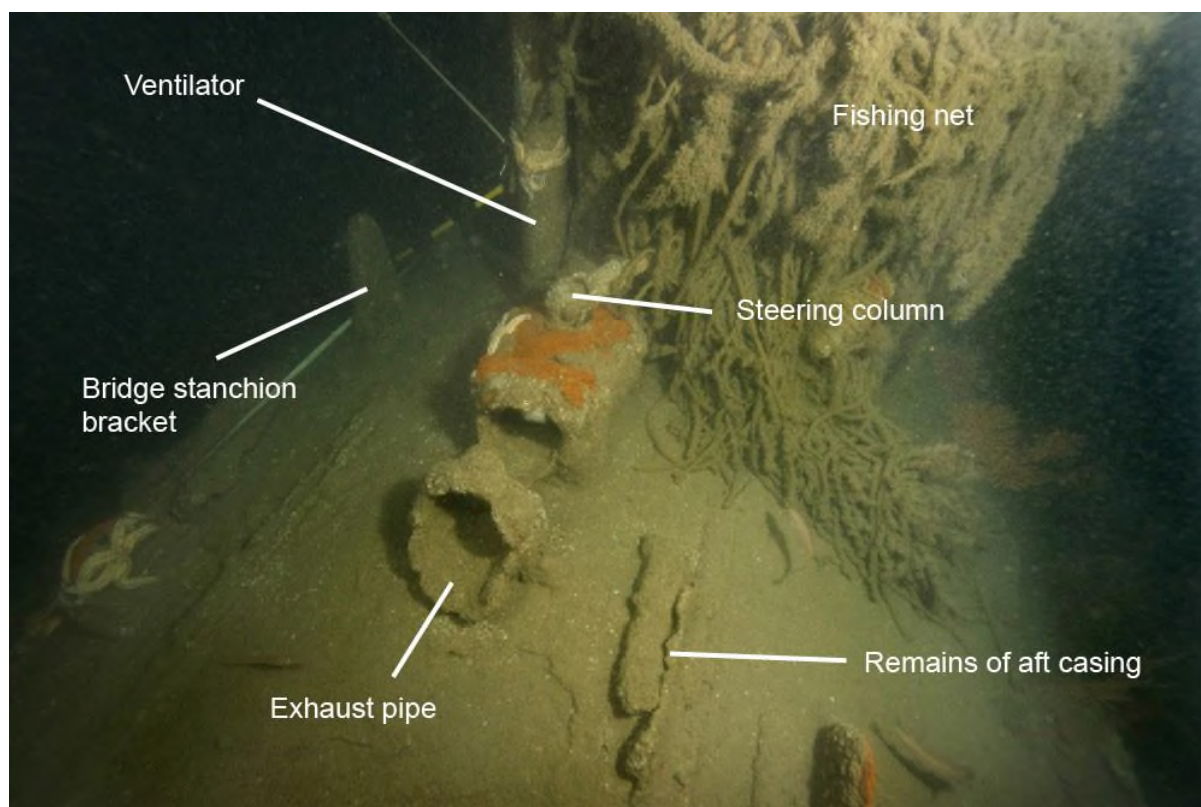
When on the surface the submarine could be steered by the coxswain while he was standing on the flying bridge. A steering column topped with a removable brass hand wheel led down from the bridge to a universal joint at deck level, through the exhaust pipe on the centreline of the submarine then into the pressure hull where it connected with the rudder controls. The remains of the steering column now lie across the hull, still connected at the universal joint to a fitting through the remains of the exhaust pipe (Fig. 49).

*Figure 49: View of the aft of the conning tower looking forward*

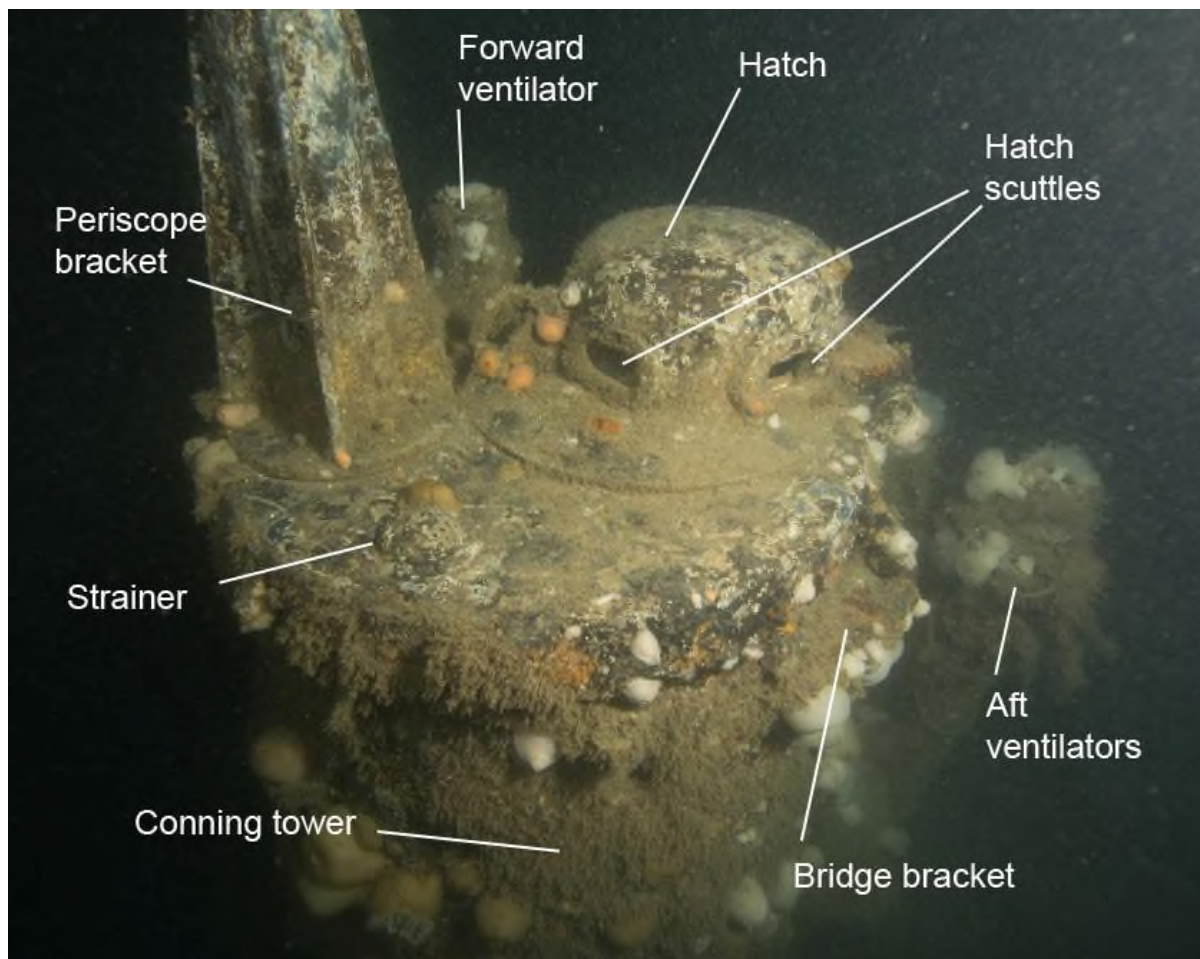
On the flat top of the conning tower are mounted the main hatch, a ventilator tube, the periscope and a strainer (Fig. 50). A small steering telegraph was once also fitted to the top but this has now been removed. The top of the conning tower appears to be made from a large copper alloy casting.

*Figure 50: Conning tower top port side looking aft*

The flat, circular main hatch is just large enough for a man to pass through, although it was noted that the crew had to take their waterproofs off first before they would fit through it. The hatch is attached to the tower by a horizontal hinge at the back so opens upwards and backwards towards the stern. A small hood or dome is mounted on the top of the hatch that has four glass scuttles around its edge and an opening handle fitted to the forward side. The glass in the forward and aft scuttles is still intact but it is broken in the scuttles on port and starboard sides.

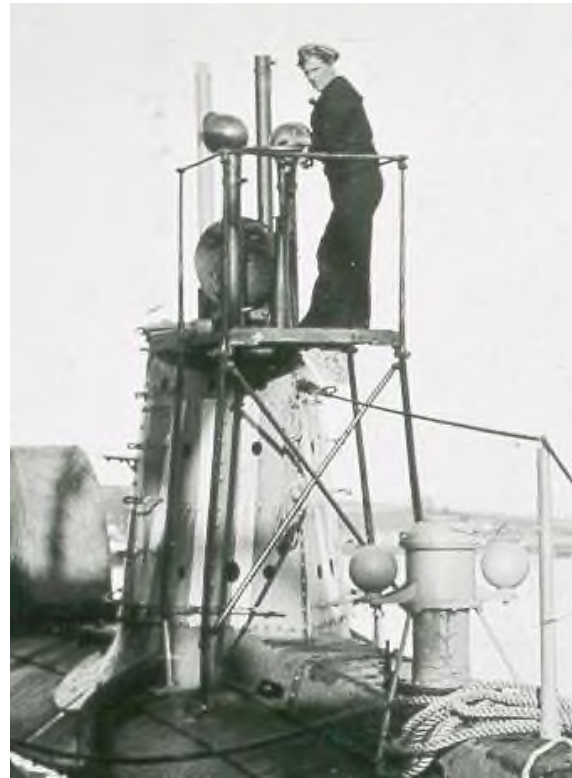
*Figure 52: The flying bridge on A7 from aft. The two ventilator tubes and cowls can be seen aft of the open main hatch*

On the A7, the flying bridge structure appears to be completely missing. However a small part may remain under the trawl net that is draped over the aft ventilators. The four brackets are still in place on the hull as are the two brackets on the back of the conning tower.

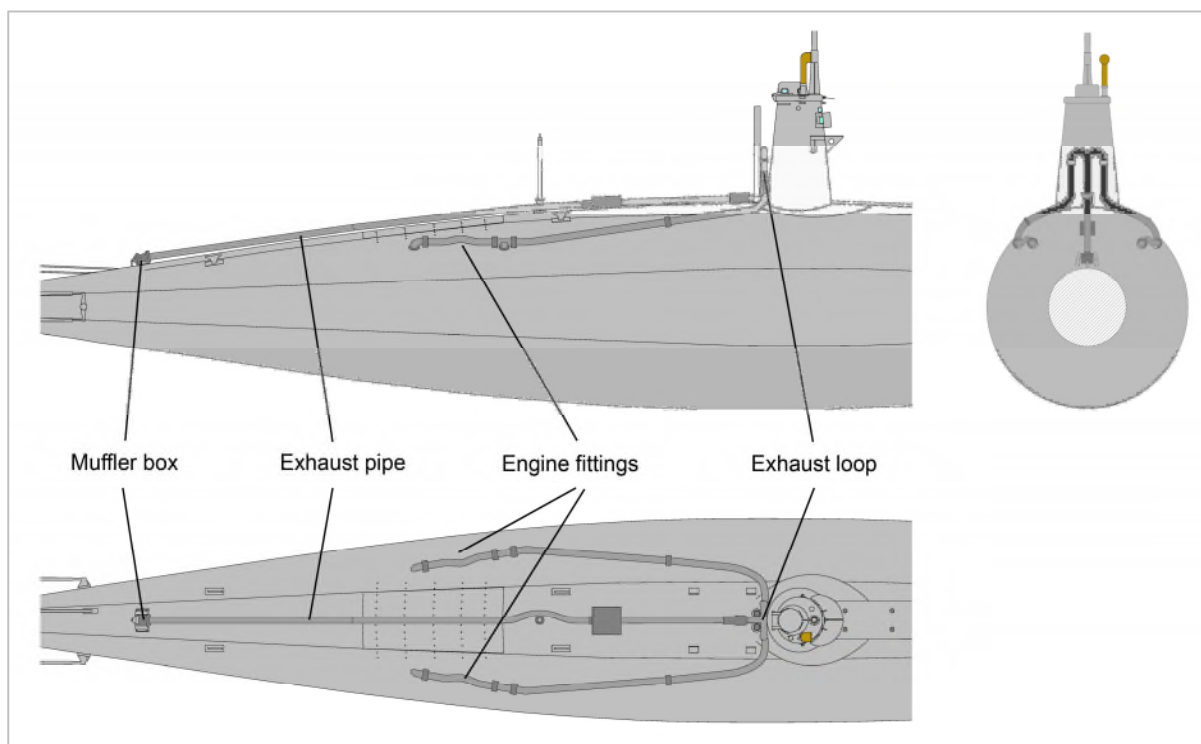
Figure 55: Drawing of the engine exhaust arrangement on the Group II boats

Remains of the exhaust pipes can still be seen on the A7. The pipes are connected to the Kingston valves by the engine but are damaged further forward so the section joining to the loop manifold behind the conning tower is missing. The loop manifold is still in place as is a short length of the single downstream pipe heading aft along the back deck. There is a break in the pipe to the short section that lies under the binnacle mounting to the aft stanchion bracket, and the section between this and the muffler box is missing. The muffler box is still in place as is the control rod that allowed the box to be opened and closed from within the submarine.

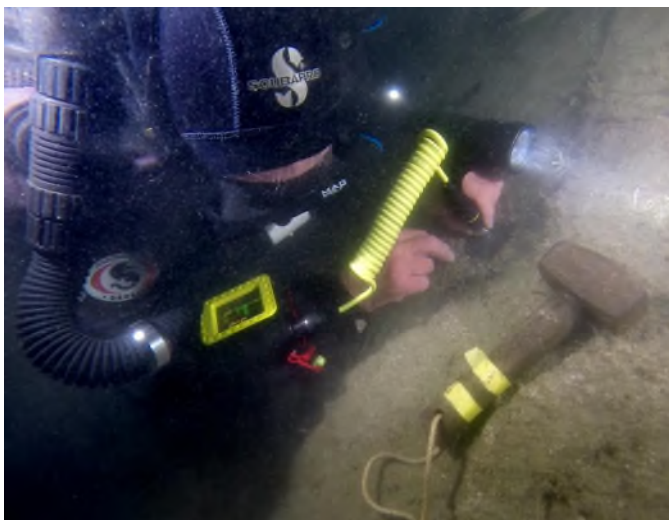
*Figure 60: Making measurements at point UT7*

Points UT7 and UT8 were 2.2m aft of the conning tower and 0.8m off the centreline on the port and starboard sides. The measurements were made on the upper edge of the second strake which was originally 11.1mm thick. The measurement for UT7 (Port) was 9.6mm and for UT8 (Stbd.) it was 9.7mm. This value is considerably thicker than the equivalent measurements made at points forward of the conning tower. It is possible that both measurements were made directly over a frame which may reduce the rate of corrosion on the inner face of the metal.

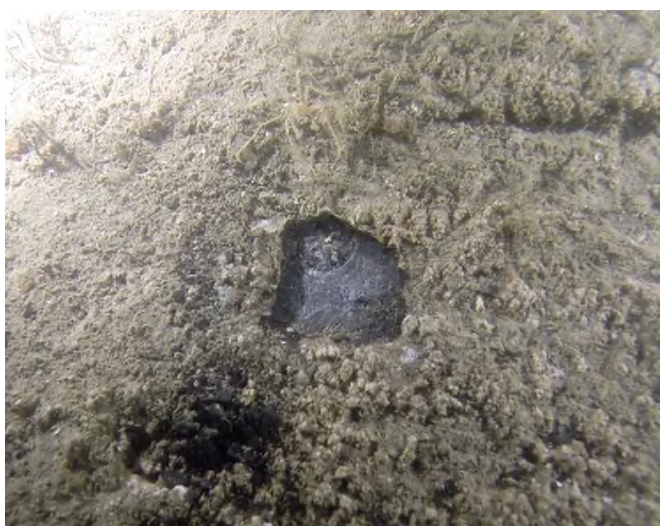
with a chisel. Under the concretion was a thin, black graphitised layer which was washed or rubbed away leaving bright and shiny metal that was uneven in texture and severely pitted (Fig. 65).

*Figure 61: A small area of concretion removed to show the bright but uneven and pitted metal underneath*

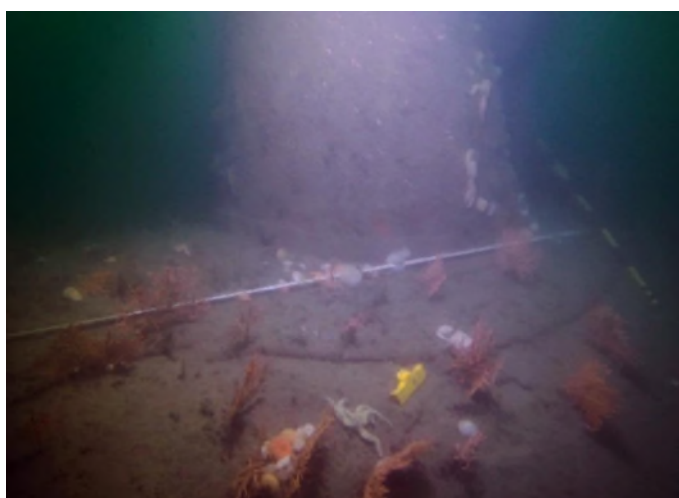
The outer corroded surface of the steel hull was quite soft and very loose in places (Fig. 65). Species noted on the hull include:

Pink sea fans, *Eunicella verrucosa* were in good condition and had a consistent orientation at right angles to the prevailing water movement which was fore and aft along the hull.

Figure 65: Base of the conning tower and hull, port side looking aft, with many pink sea fans

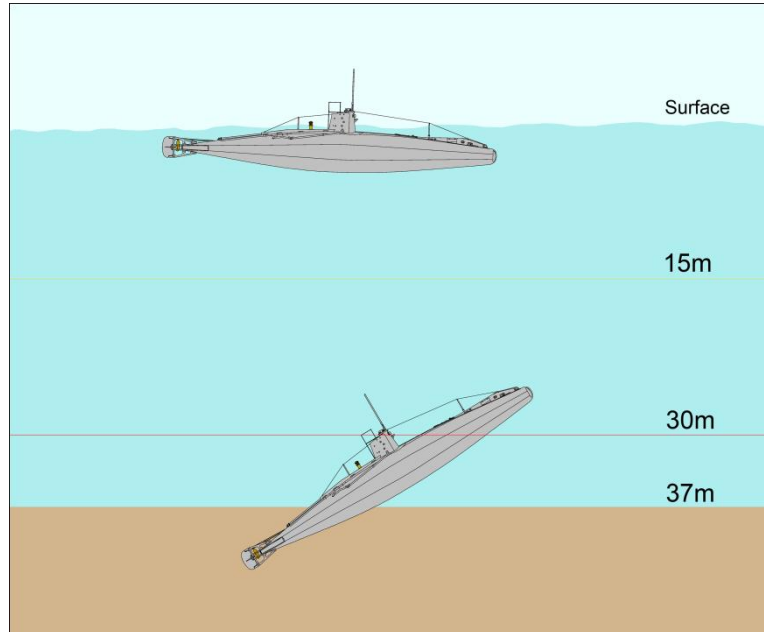
The wreck was found in 37m depth with between six and seven metres of the submarine's stern buried in the muddy seabed and the bow 10m off the bottom<sup>115</sup>, raised at an angle of 30° to 40° (Fig. 76). The visible part of the pressure hull appears to be undamaged apart from three small holes which were probably caused by corrosion. The damage to the towing eye, cutwater and aft exhaust pipes are consistent with reports of damage that occurred during salvage. The main conning tower hatch and torpedo loading hatch are firmly closed so neither were left open causing the hull to flood.

*Figure 76: A7 as she was found partly buried in the seabed, also showing working depth (15m) and maximum operating depth (30m)*
